2021 PRIOR LAKE OUTLET SYSTEM ANNUAL OPERATIONS REPORT

PRIOR LAKE-SPRING LAKE
WATERSHED DISTRICT

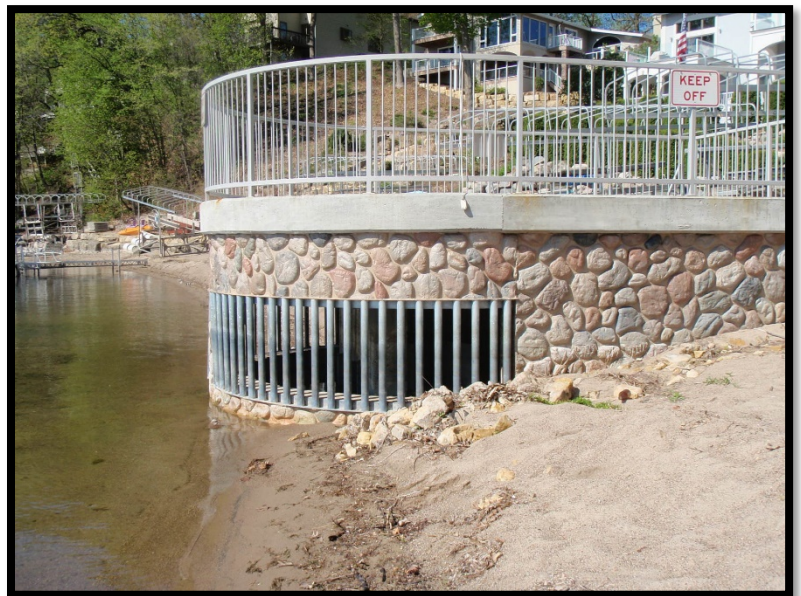
FIGURE 1 OUTLET STRUCTURE

Given these conditions, a replacement structure was pursued by the District and installed in 2010 (Figure 1). The new design has increased the efficiency of discharging water by allowing the outlet pipe to reach capacity sooner. It also provides safer conditions for staff during inspections and maintenance and is self-operating which reduces overall operations and maintenance costs. A schematic of the outlet structure is provided in Attachment A.

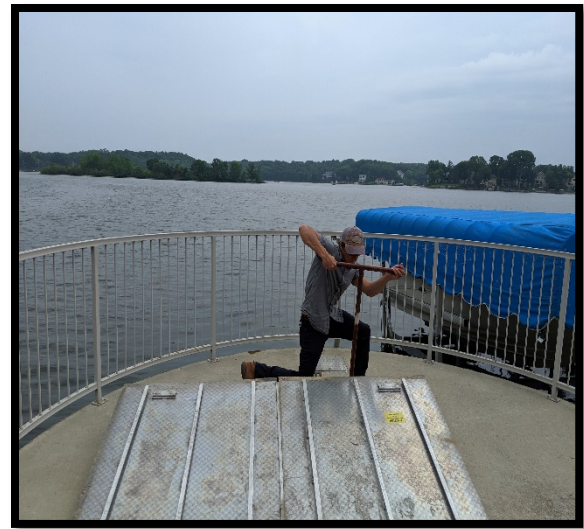
FIGURE 3 – OPENING THE LOW-FLOW GATE

At certain lake levels, the low-flow gate allows more water through the outlet structure, resulting in the lake level lowering more quickly and creating more storage (see Attachment C). The low-flow was not operated in 2021 due to low water levels and shortage of precipitation. The stage-discharge relationship curve is used to calculate flows and water quantities leaving Prior Lake. (see Figure 3).
