2022 PRIOR LAKE OUTLET SYSTEM ANNUAL OPERATIONS REPORT

PRIOR LAKE-SPRING LAKE
WATERSHED DISTRICT

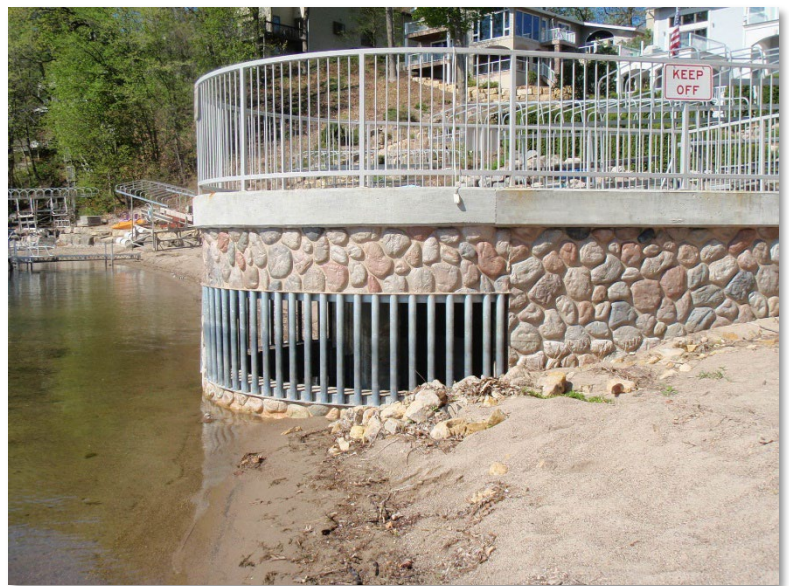
FIGURE 1 - OUTLET STRUCTURE

Given conditions, a replacement structure was pursued by the District and installed in 2010 (Figure 1). The new design has increased the efficiency of discharging water by allowing the outlet pipe to reach capacity sooner. It also provides safer conditions for staff during inspections and maintenance and is self-operating which reduces overall operations and maintenance costs. A schematic of the outlet structure is provided in Attachment A.

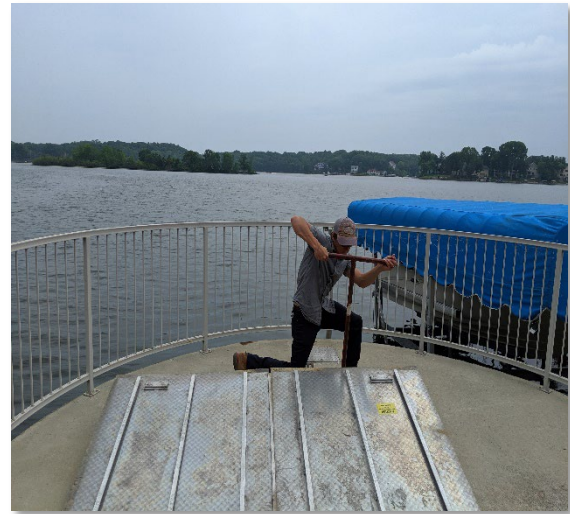
FIGURE 3 - OPENING THE LOW-FLOW GATE

At certain lake levels, the low-flow gate allows more water through the outlet structure, resulting in the lake level lowering more quickly and creating more storage (see Attachment C). The low-flow gate was not operated in 2022 due to low water levels and shortage of precipitation (Figure 3). The stage-discharge relationship curve is used to calculate flows and water quantities leaving Prior Lake.

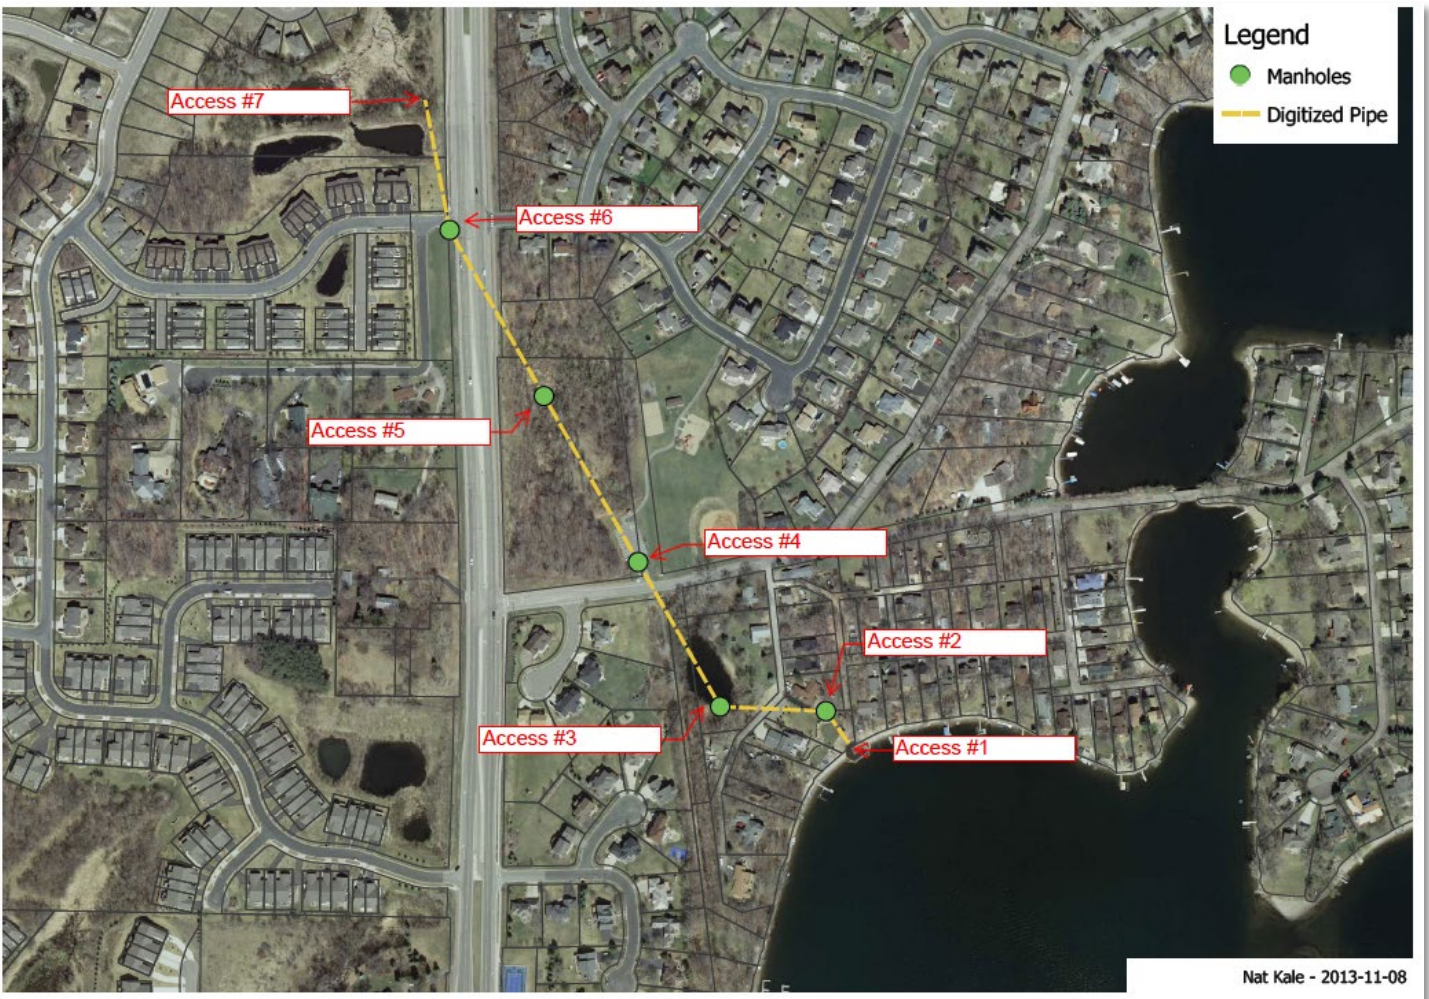
FIGURE 5 - MAP OF OUTLET PIPE

The Outlet Pipe leads from the Outlet Structure to the beginning, or “daylight,” of the outlet channel (Figure 4). It is buried underground for approximately 2075 feet, with 5 manholes and 7 access points (Figure 5).

In 2022, American Environmental televised the pipe and found that the pipe is still in good to fair condition. However, many small longitudinal cracks, light to medium leaks, and light to medium mineral deposits around joints (sign of

infiltration) were observed throughout entire length of the pipe. The contractor suggested cured-in-place-pipe (CIPP) lining as a suggested fix for the current observed issues. The pipe review summary is shown in Attachment H.
