2011 Prior Lake Outlet System Annual Operations Report

Attachment A: Prior Lake Outlet Structure Diagram

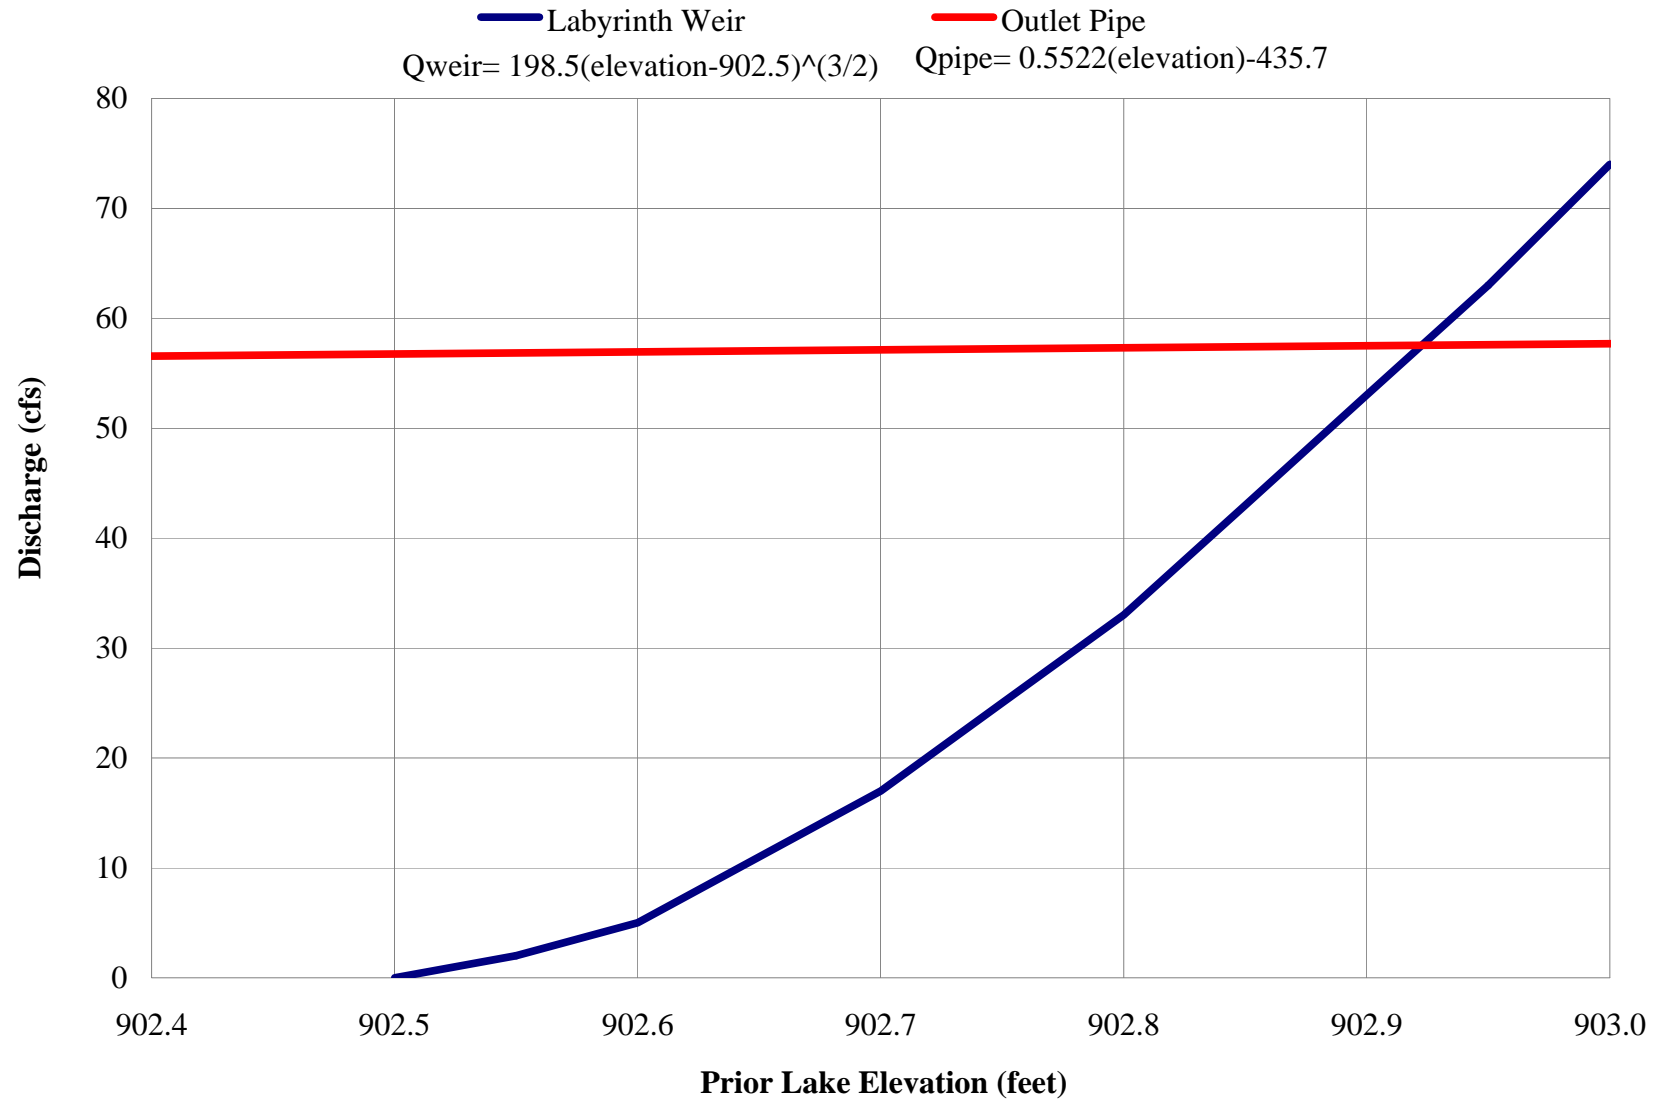
Attachment C:
Stage-Discharge Relationship

Prior Lake Outlet Stage-Discharge Relationship

The new outlet structure has increased the efficiency of discharging water by allowing the outlet pipe to reach capacity sooner. It has also proven to provide safer conditions for staff during inspections and maintenance, and is self-operating, which will reduce overall operations and maintenance costs. A schematic of the new structure is provided in Attachment A and a graph showing the modeled stage-discharge relationship (rating curve) can be seen in Attachment C. A field verified rating curve for the new structure is being developed as flow data collected is sufficient to do so.
