# PRIOR LAKE - SPRING LAKE

2012 Prior Lake Outlet System Annual Operations Report

# **2012 Prior Lake Outlet System Annual Operations Report**

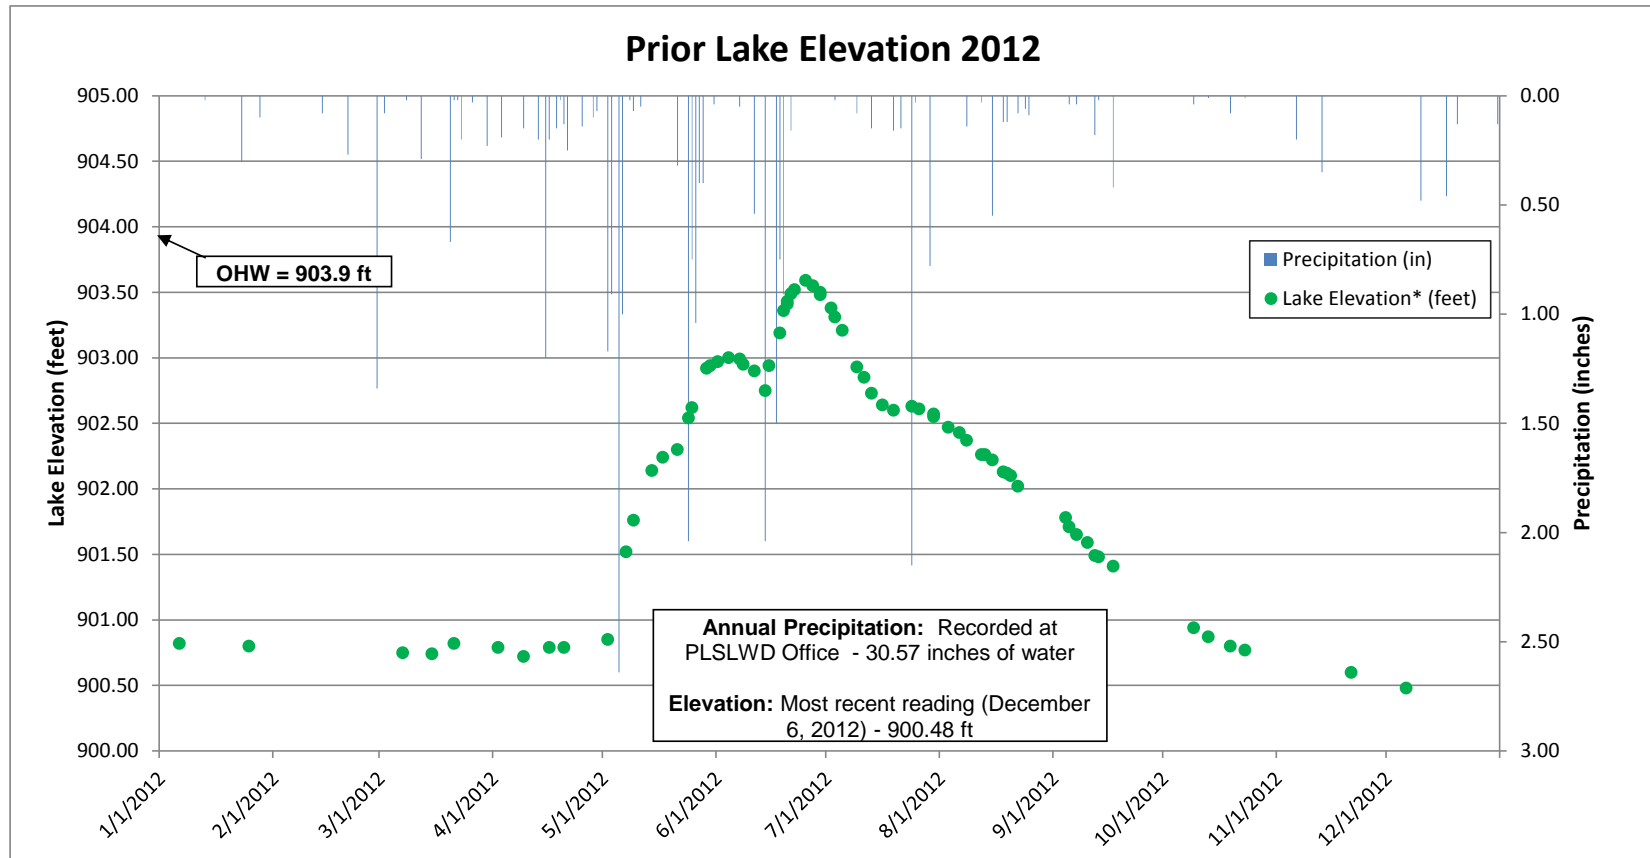
Attachment F:  
Prior Lake Elevations Graph

Elevation		Precipitation	
Average	902.19	Yearly Total	30.57
Minimum	900.48	Max 1 Day	2.64
Maximum	903.59
